Co₂olBricks

Refurbishment for the energy efficiency of historic buildings in member states in the Baltic Sea Region

A handbook of the “most common methods for improvements to energy efficiency”

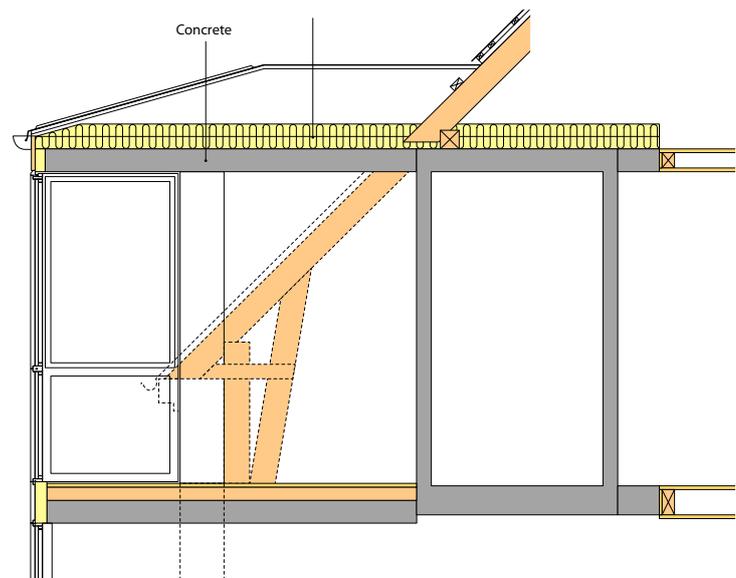
Vertical section of the roof above the apartment in the former attic room.

Furthermore, the 45 degree angled double-pitched roof was also replaced. Insulation (150 to 230 mm mineral wool) was installed between the rafters and on the floorboards in the ventilated attic room. The cellar ceiling was supported by good-quality timber beams with the dimensions 200 mm by 200 mm. The ceiling was lowered and insulated with 100 mm mineral wool, and along with it a new cladding (13 mm gypsum boards) was installed.

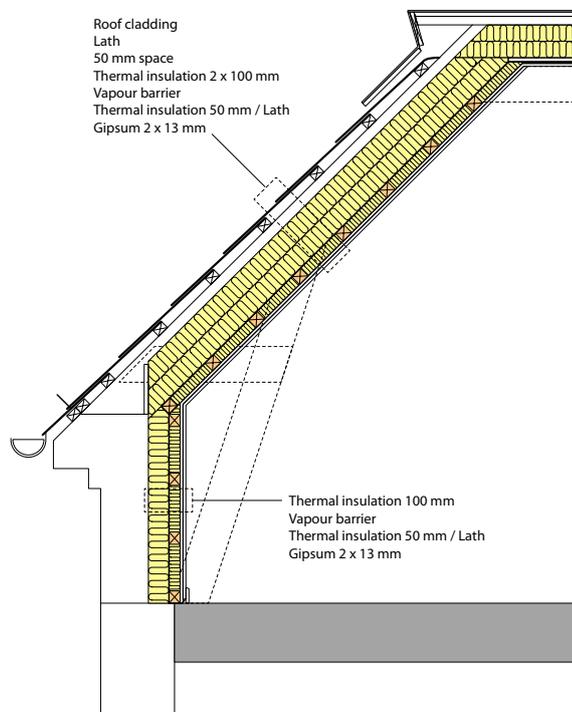
Vertical section of the roof above the apartment in the former attic room.

Furthermore, the existing 45 degree angled double-pitched roof was replaced and insulated between the rafters with 200 mm mineral wool. No measures were implemented in the basement. The cellar ceiling with horizontal partition by timber beams are of a good quality with the dimensions 200 mm by 200 mm.
